Field Visit Report
Karawdigana Wewa Rehabilitation (Phase II – CSIAP)
Southern Province

The World Bank financed Climate Smart Irrigated Agriculture Project (CSIAP)
Ministry of Agriculture, Livestock, Land and Irrigation

FIELD VISIT REPORT

Date of Visit: 20/05/2025

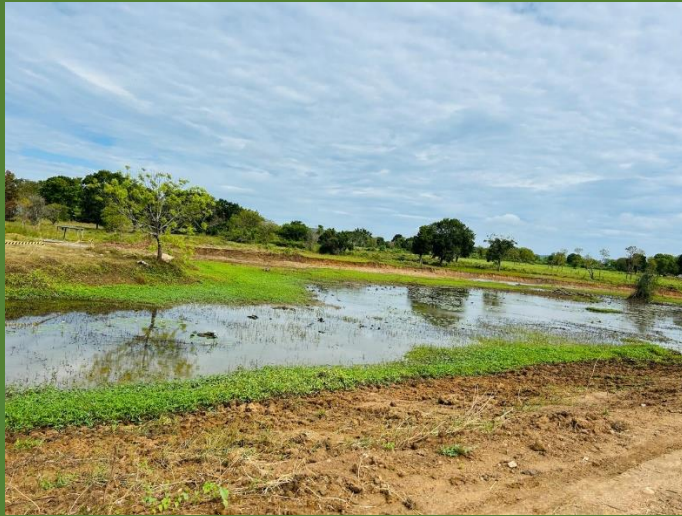
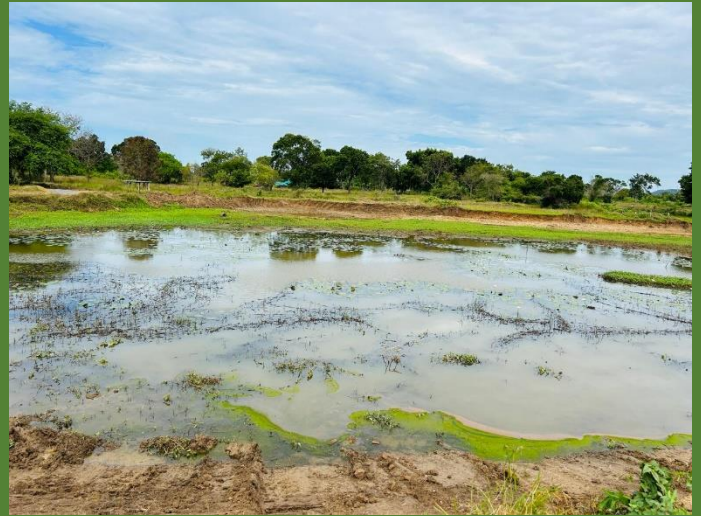
Desilting and Management of Dredged Material

Desilted (dredged) material is being temporarily stored in the contractor's yard and will be managed by the implementing agency in line with departmental procedures. Due to the large volume of dredged soil, it will not be distributed to individual farmers, in order to:

The soil has been tested by the implementing agency and determined to be unsuitable for bund rehabilitation due to its clay composition.

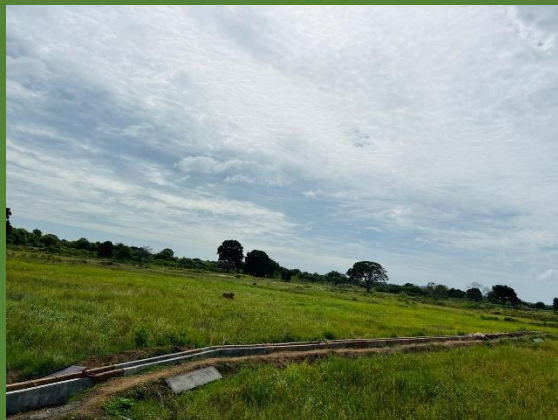
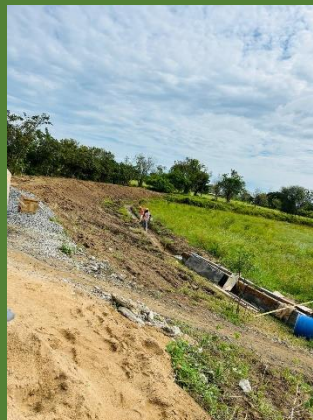
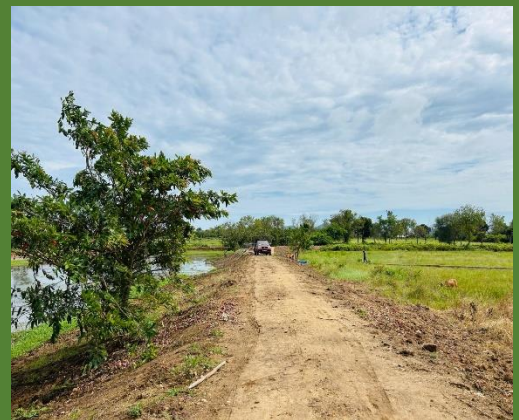
- **Downstream canal rehabilitation** and **bund rehabilitation** were actively ongoing at the time of the visit.
- **Stripping work** was not yet initiated.
- **Seven laborers** were present on-site, supervised by the site supervisor and contractor.
- The **Social Audit Committee (SAC)** members and **Farmer Organization representatives** were also present.
- Work commenced on 21st April 2025 and has continued consistently, except for a pause on the previous day due to heavy rainfall.

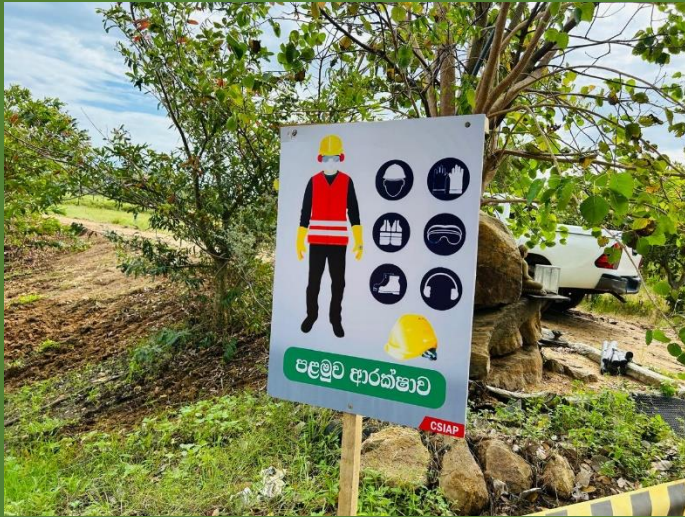
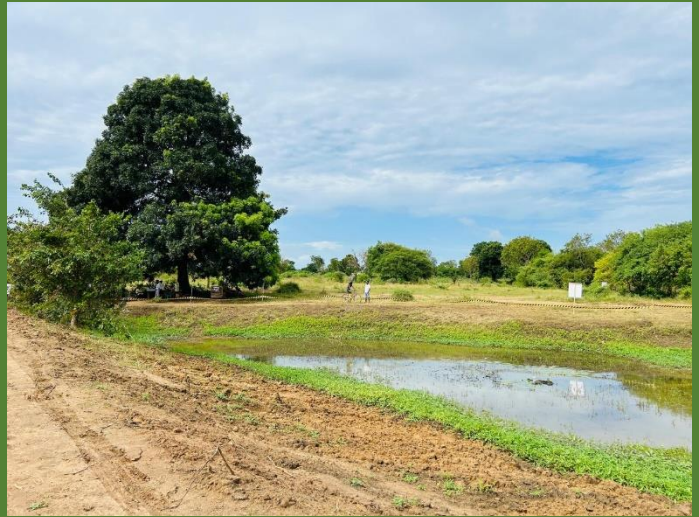
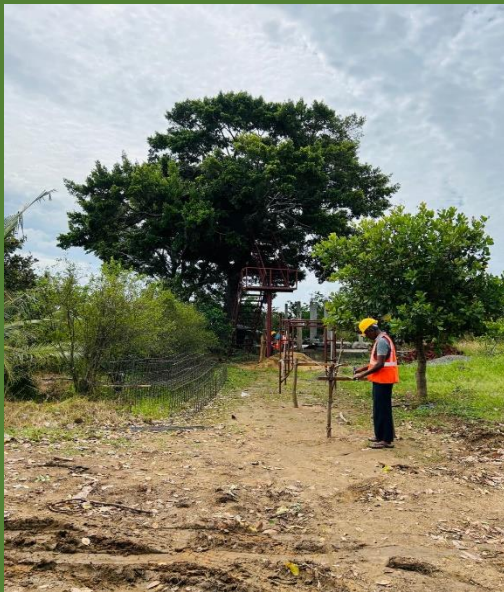
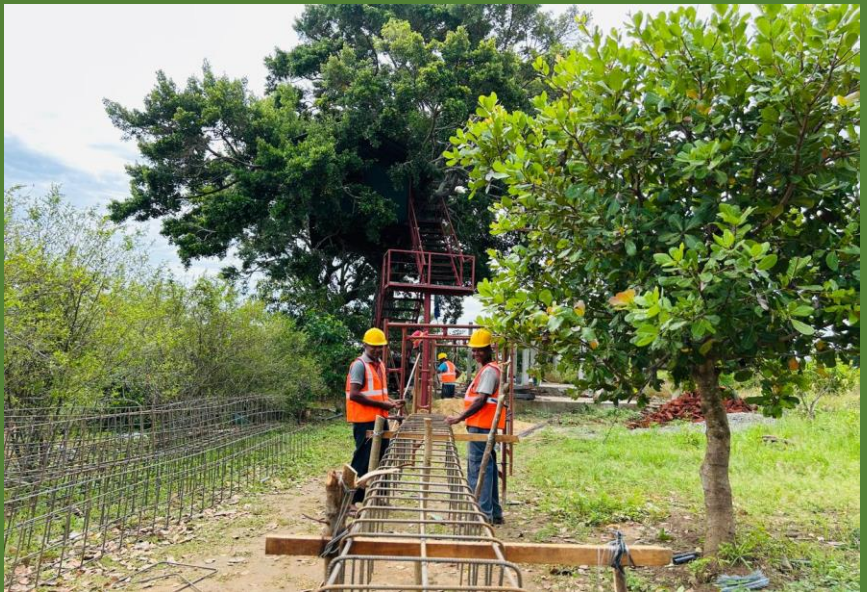
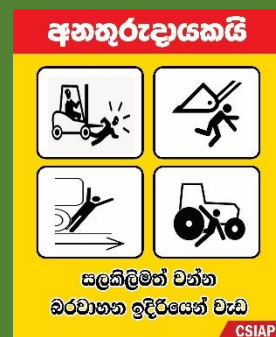
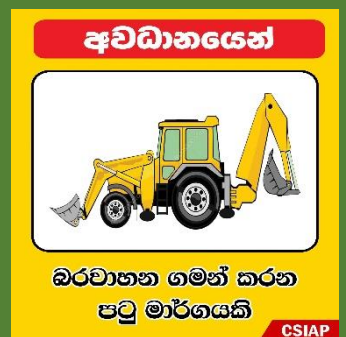
- Adequate safety measures and warning signboards were observed at the site.
- The contractor and workers were complying with standard OHS protocols.

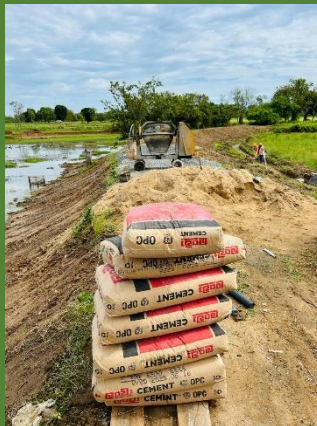
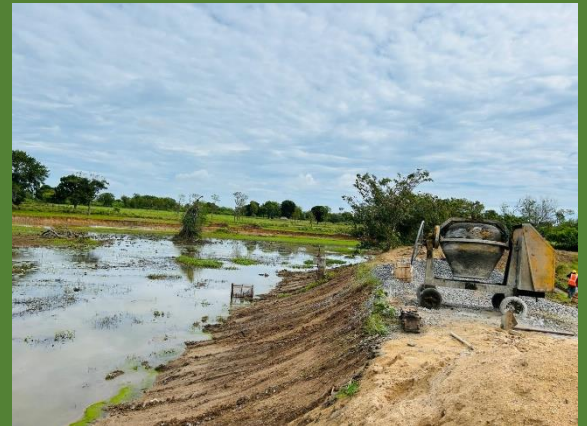
Material storage was observed at the site.

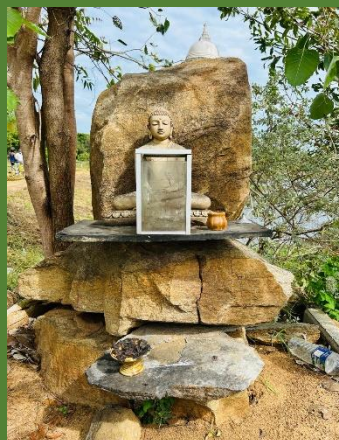
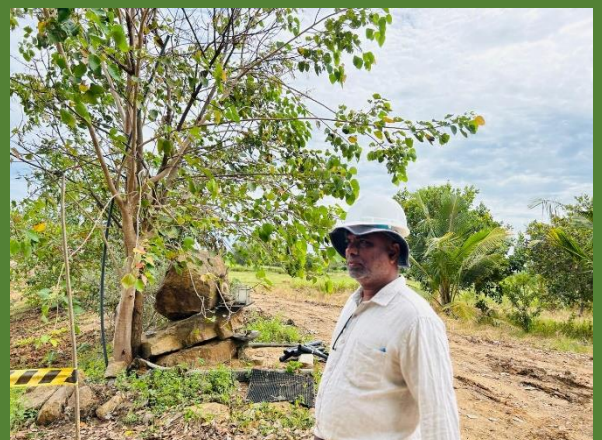
No damage to cultural properties was caused by the contractor or workers during the rehabilitation work.

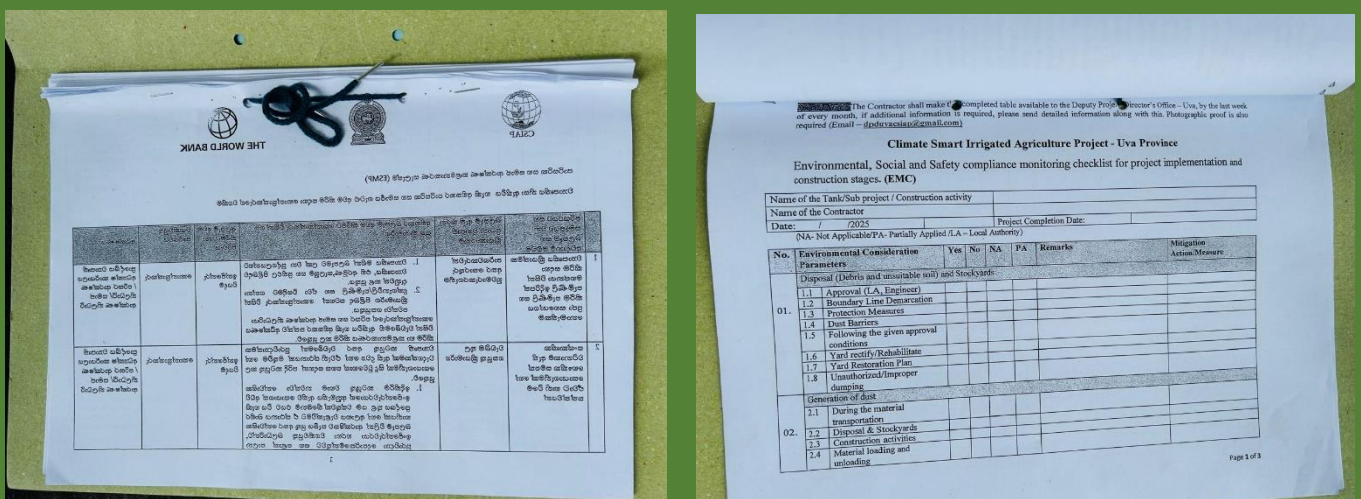
Instructions were given to the contractor regarding compliance, and the site-specific checklist for Environmental and Social Management Plan (ESMP) was also available at the site.

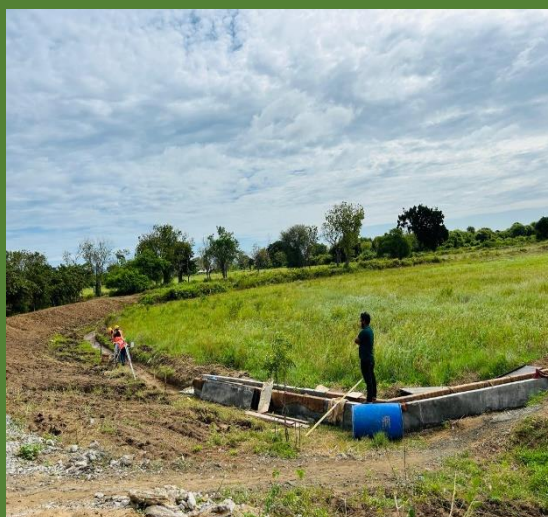
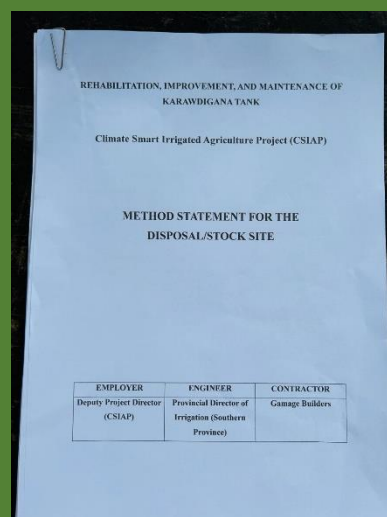
The supervisor was present at the worksite during the inspection.
