Field Visit Report
Karawdigana Wewa Rehabilitation (Phase II – CSIAP)
Southern Province

The World Bank financed Climate Smart Irrigated Agriculture Project (CSIAP)
Ministry of Agriculture, Livestock, Land and Irrigation

FIELD VISIT REPORT

Date of Visit: 20/05/2025

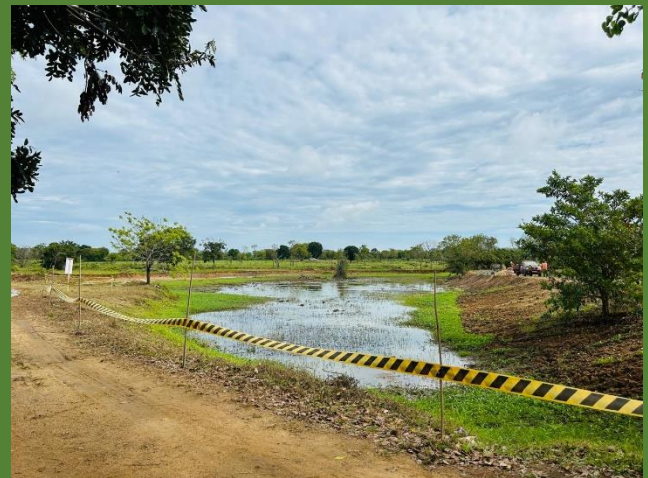
Overview of Ongoing Works: Both upstream and downstream interventions are being undertaken at the tank. The key activities observed during the visit include:

- Desilting operations
- Spill repair
- Bund rehabilitation

The site is located adjacent to a Forest Department boundary.

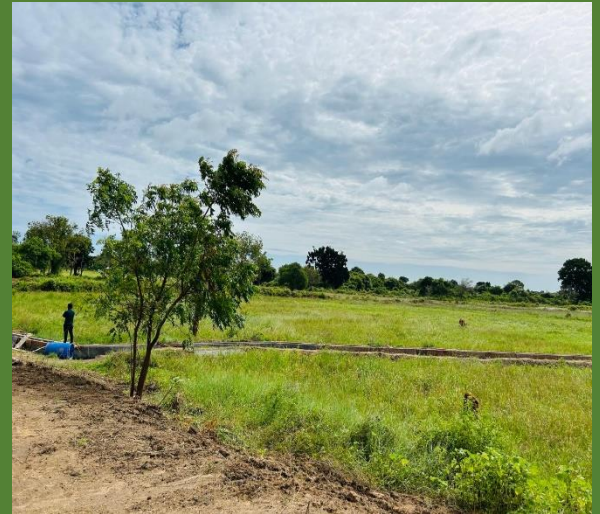
- An **artificial drawdown of tank water** had been conducted prior to the visit, with the consent of local farmers.
- Farmers agreed to forego **Yala season cultivation** as part of the drawdown strategy. They had already harvested **Maha season paddy** (15 acres cultivated by 15 farmers).
- The farmers requested **green gram seeds as compensation** to utilize the mid-season for cultivation. They expect delivery by June 2025.

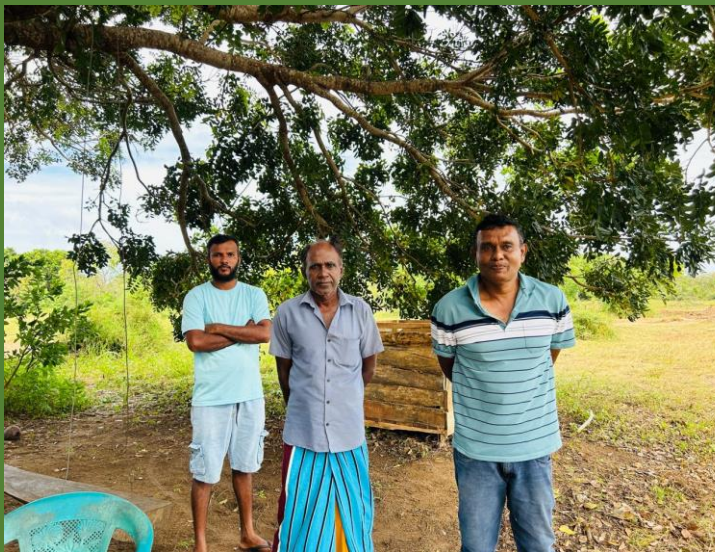
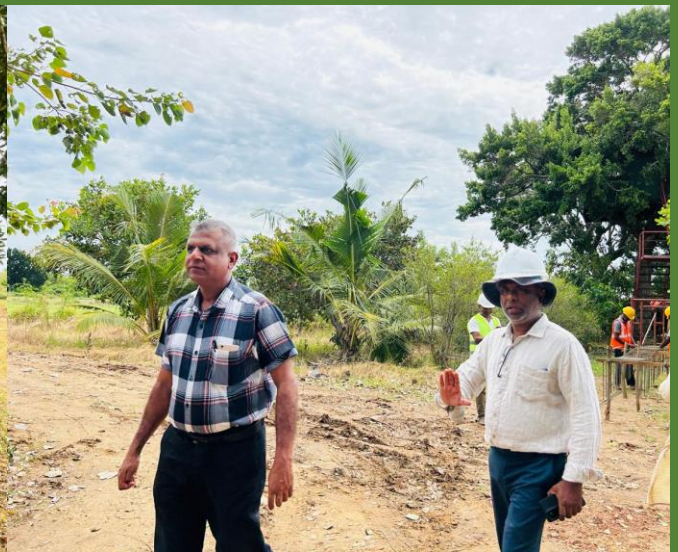
- The contractor reported hiring **14 local laborers** and **11 tractors** from the village for project activities. This was confirmed by SAC members and demonstrates effective community engagement.
- The SAC consists of **5 rotating members**, who regularly monitor and record project progress.
- Site-specific **logbooks and documentation** are maintained in an organized manner.

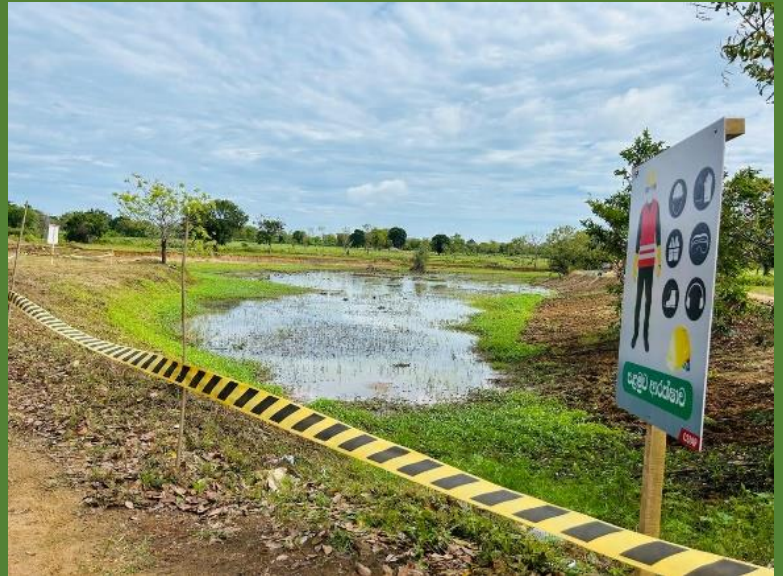
- No separate labor camp is established on-site due to the wildlife movement.
- From the **main road to the sub-road**, safety signage was properly displayed, indicating good practice in traffic and safety management.
